40th INTERNATIONAL CONFERENCE ON PRODUCTION ENGINEERING - SERBIA 2025

QUANTITATIVE ANALYSIS OF TOOL WEAR IN DEEP HOLE DRILLING

Abstract: *This paper presents an experimental procedure for the automatic detection and quantitative evaluation of surface wear on drills used in deep hole drilling processes. The analysis was based on images of the cutting edge captured by an industrial camera under controlled conditions, with a particular focus on the curved edge segment, which is especially prone to wear. A custom image processing algorithm was developed within the MATLAB programming environment, employing a multi-stage approach—preprocessing, surface condition classification, and distance analysis of worn zones from the curved edge—to calculate VB_{mean} as an indicator of wear severity. The algorithm successfully distinguishes between healthy regions, grinding marks, mechanical damage, and active wear, significantly reducing the risk of misinterpretation. Quantitative analysis performed on a dataset of 50 samples demonstrated repeatability of the results and potential for further industrial application. The observed wear patterns may serve as a basis for optimizing process parameter

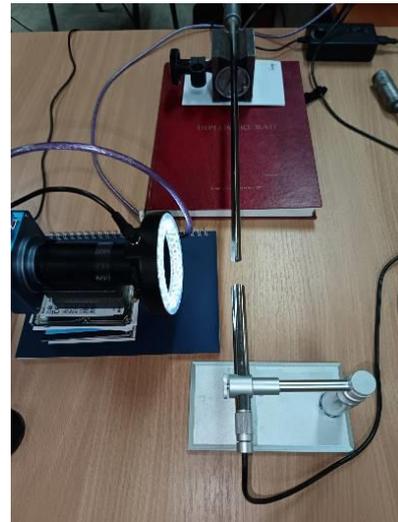
The experimental setup involved horizontal fixation of the drill using a precision prism, with simultaneous image acquisition from two cameras: an industrial camera (48 MP FHD Camera V8, C-mount lens, optical zoom 8×–100×) equipped with side-mounted ring lighting, and a front-facing Vividia 2.0 MP handheld USB digital microscope. This configuration enabled high-resolution imaging of the curved cutting edges, providing sufficient detail for subsequent image processing and quantitative wear analysis (Fig.1).

Figure 1. Experimental setup for visual analysis of drill wear

This configuration enables simultaneous observation of both the lateral surface and the tool's tip (Fig. 2), providing comprehensive visual information about the condition of the cutting edge. The lighting system was optimized to eliminate shadows and reflections, while image acquisition was performed via a computer under controlled, vibration-free conditions.

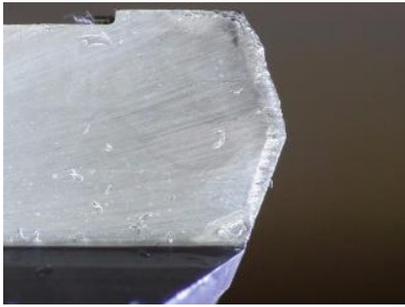
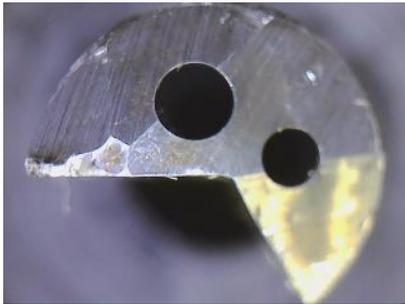
Figure 2. Representative images of tool wear captured from two angles: (a) side view, (b) frontal view captured with a microscope camera

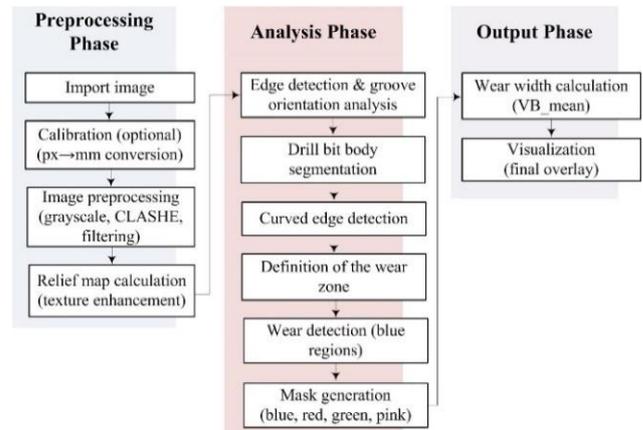
The algorithm structure is organized into three logical stages (Fig. 3):

1. The preprocessing phase includes importing the input image and preparing it for further analysis. The image is first converted to grayscale (Fig.4a), followed by local contrast enhancement using the CLAHE (Contrast Limited Adaptive Histogram Equalization) (Fig.4b) method with parameters: tile grid size 8×8 and clip limit 0.01. Gaussian filtering ($\sigma = 0.8$) is then applied to reduce noise. To enhance the visualization of surface texture, a so-

Figure 3. Tool wear detection algorithm

2. The analytical phase involves segmentation of the drill body and extraction of the curved edge on the frontal surface. Wear regions (blue zones) are identified using a robust threshold defined by the median and robust standard deviation ($k = 0.5$). Simultaneously, an analysis of groove orientation is performed to detect grinding marks (green regions) and mechanical damage that deviates from the dominant direction (red regions);

3. The results phase includes quantitative evaluation of wear. The VB_{mean} parameter is calculated as the median distance of the detected blue regions from the curved cutting edge. The result is presented as a colour map (Fig.5) allowing for intuitive visualization of the tool condition.

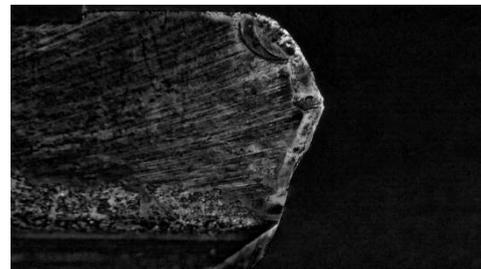
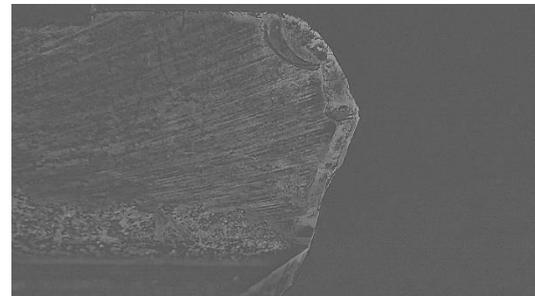
Figure 4. Preprocessing phase: a) Grayscale image, and b) Local contrast enhancement

The experimental algorithm was applied to a sample of 50 tool images with the aim of quantitatively and visually assessing tool wear. The key processing stages—preprocessing, surface classification, and extraction of relevant regions—were presented in the previous section (Fig. 4 and Fig. 5). Based on the extracted blue regions (identified as wear) and their distance from the curved edge, the average wear width (VB_{mean}) was calculated.

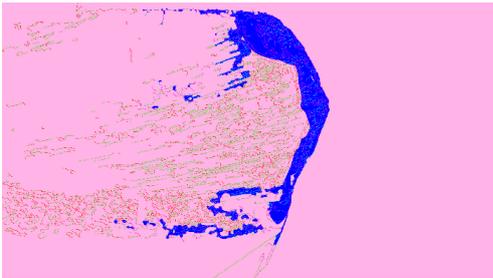
Figure 5. Drill condition map (pink - healthy surface, blue - wear, green - grinding marks, red - damage)

For the representative example, the average wear width was determined to be $VB_{mean} = 90$ px (approximately 109.51 px = 1 mm).

Additionally, the local distribution of the shown worn areas also testifies to local loading—dominant in this case in the upper right portion of the edge (Fig. 5). It is a result of faulty cutting conditions, tool geometry, or poor heat removal during the drilling process. The visual examination of the classified image also facilitates the identification of other potentially harmful features, including grinding marks (potentially indicating prior sharpening) and localized damage (also in need of analysis). Through this, the output from the algorithm contributes to further knowledge about the condition of the tool, enabling not only evaluation of current wear but also potential classification of samples by level of degradation.
